**Failure Analysis, Cadmium Brush Plate Qualification and
Salt Fog Testing of the AH-64 Shock Strut Mount,
P/N 7-311113409**

ARL-TR-2870

November 2002

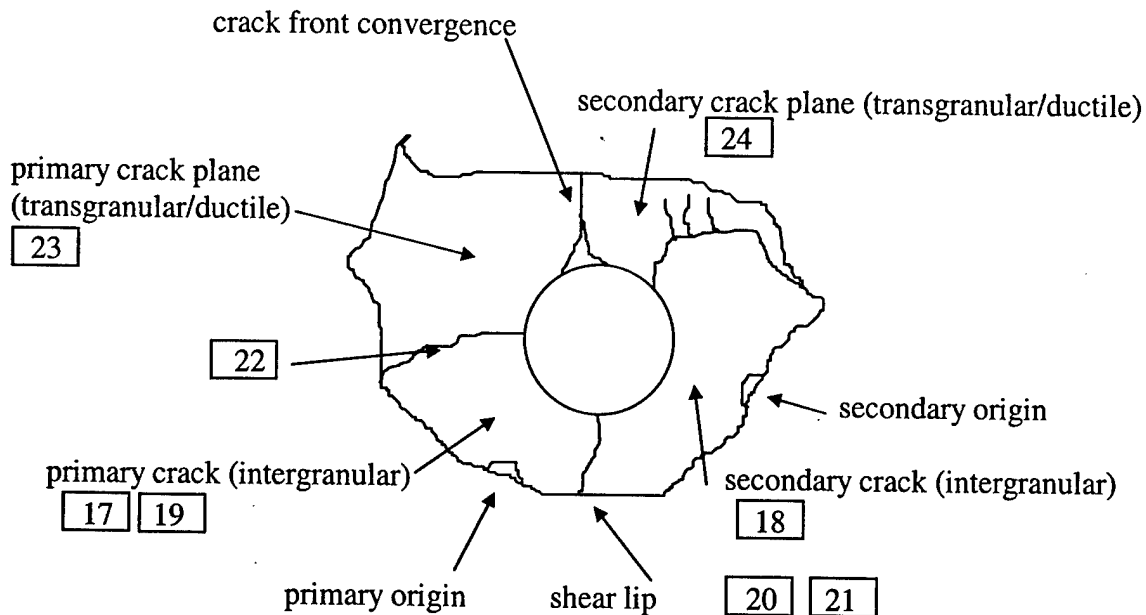
The fracture surface of the component was subsequently examined using the scanning electron microscope (SEM) in order to determine the fracture morphology and fracture mechanism. The fracture surface was ~50% intergranular (the primary crack comprised 20%, while the secondary crack was 30%). Figure 16 is a schematic showing the fractographic features of the surface. The

Figure 16. Schematic of fracture features as determined through SEM. Numbers in boxes correspond to figure locations.

morphology of the both the primary crack and the secondary crack was intergranular, as shown in Figures 17 and 18. Note the textbook “rock candy” morphology and the secondary cracking typical of a brittle fracture. Figure 19 (taken within the secondary crack fracture surface) shows this morphology at increased magnification. Note the evidence of micro-pores, which are typical of 18% nickel maraging steel hydrogen-assisted failures [5]. These two crack fronts were separated by a shear lip, which failed in a ductile manner, as evidenced by the morphology shown in Figure 20. Figure 21 shows the transition zone between the secondary crack and the adjacent shear lip that separated the two crack fronts. Figure 22 shows the transition zone between the primary crack and the transgranular/overload morphology. This was also typical of the transition zone between the secondary crack and the transgranular/overload region. Figures 23 and 24 show the transgranular/overload morphology that made up ~45% of the fracture surface. Figure 25 shows this morphology at higher magnification. As shown, this surface morphology represents very low cycle fatigue, in which the loading produces not only the transgranular morphology typical of fatigue, but also ductile dimples indicative of tensile overload. No fatigue striations were discernible within the transgranular/overload regions. An attempt was made to examine the fracture origins; however, the corrosion, as well as the nature of brittle failures, made it difficult to pinpoint the exact sites with 100% accuracy.

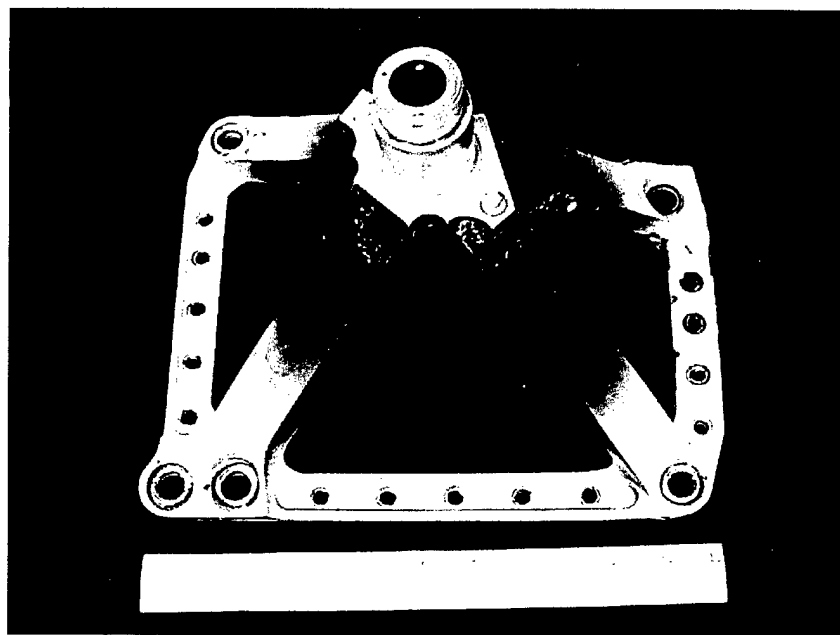
The U.S. Army Aviation and Missile Command (AMCOM) requested the qualification of two facilities for the cadmium brush plating of AH-64 landing support struts (shown in Figure C-1). The facilities would perform rework in the spindle to webbing radius that has been the origin of many failures over the past decade. As part of the qualification process, the U.S. Army Research Laboratory (ARL) performed hydrogen embrittlement testing on specimens that were cadmium brush plated by the Hunter Army Air Field (HAAF), Savannah, GA, and Ft. Lewis, WA. Each facility used a "no-bake," non-embrittling solution for plating. The specimens were produced in accordance with American Society for Testing and Materials (ASTM) G39¹ from two separate AH-64 Landing Support Struts comprised of Maraging 300 Grade steel. Each specimen withstood 8 weeks of ambient exposure (75 °F and 50% relative humidity) at 80% and 92% ultimate tensile strength (UTS) loading without failure. Based upon the results of ambient loading, the two facilities were qualified to perform cadmium brush plating operations.

Figure C-1. Intact shock strut mount shown in the as-received condition (reduced 75%).

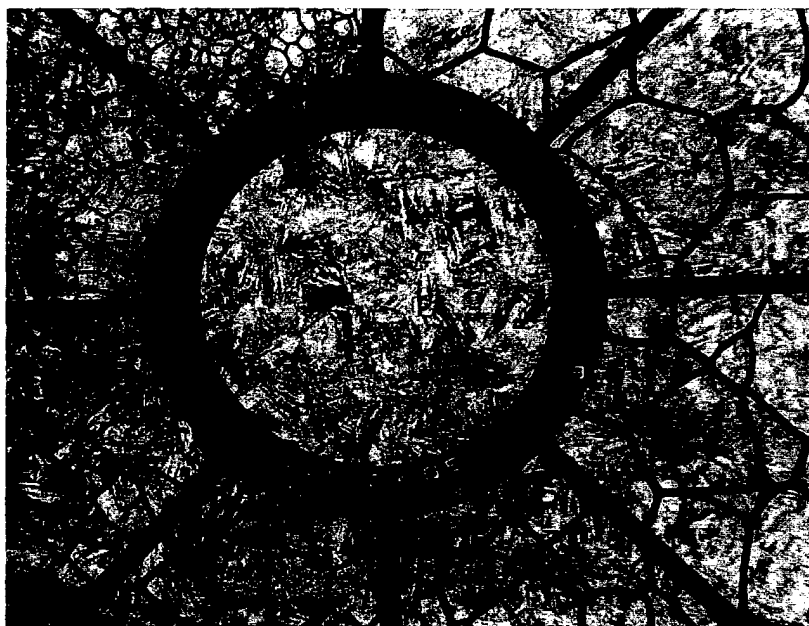
Representative SCC specimens coated by HAAF and Ft. Lewis were sectioned in order that a metallographic examination could be performed. Transverse and longitudinal samples were polished then etched with Marble's Reagent (4-g CuSO₄, 20-mL HCl, and 20-mL deionized water). The structure was similar in both orientations, consisting of an aged, low-carbon martensite. In addition, the material was fairly clean, exhibiting no gross defects or inclusions. Paragraph 3.4.1.3 of specification HMS 6-1081 requires a grain size of no. 7 or finer with an occasional no. 5 unless otherwise specified for material up to 3-inches in diameter or square. The grain size was determined using a metallograph with grain size reticle conforming to ASTM E112.³ It was determined that the grain size was between ASTM nos. 6 and 7 at 100× magnification for both the HAAF and the Ft. Lewis specimens (Figures C-3 and C-4), and no appreciable difference existed between the two.

Figure C-3. Grain size of a representative HAAF specimen (mag. 100×).

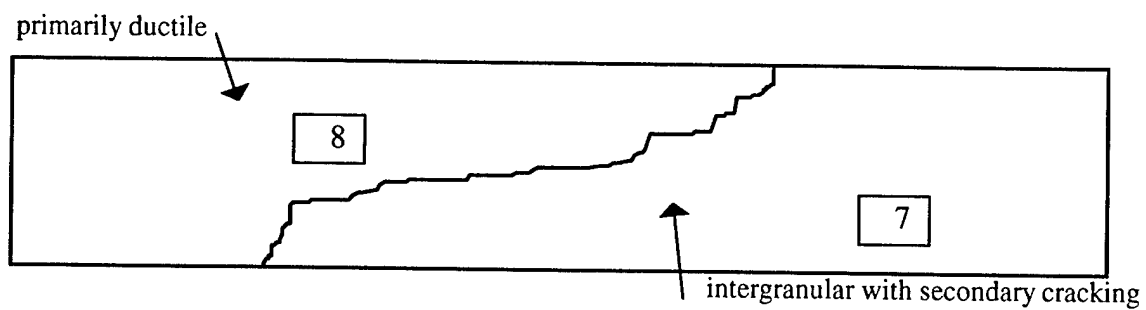
Figure C-6. Schematic illustrating a mapping of the fractographic features of the surface shown in Figure C-5. Boxes show locations of Figures C-7 and C-8.

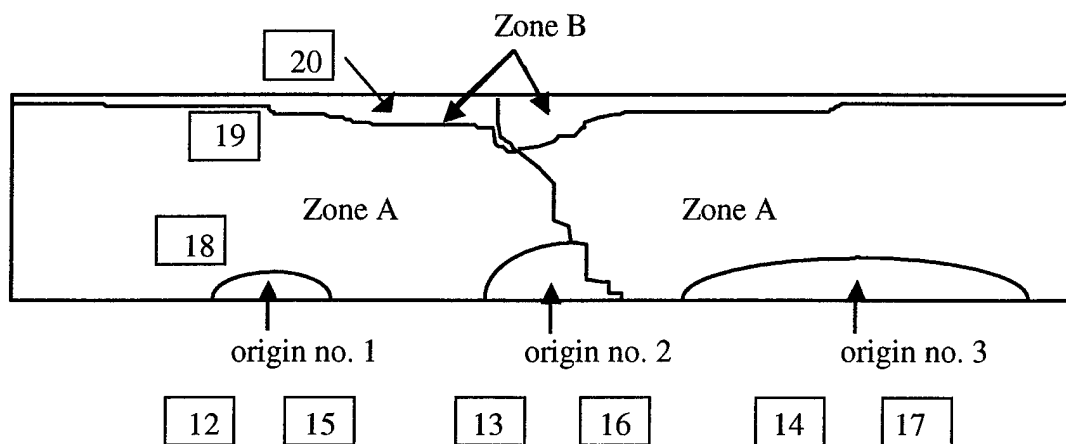
Figure C-9 contains a montage of a typical Ft. Lewis failure, while Figure C-10 contains the accompanying schematic map. The fracture surfaces of the broken Ft. Lewis specimens consisted primarily of a transgranular, quasi-cleavage morphology (Figure C-11). The fracture of one of the specimens consisted of two planes with three distinct origins on the tensile side of the specimen and had the appearance of a ductile fracture. The surface was predominantly transgranular with evidence of intergranular attack and secondary cracking only at each of the three origins. Ductile dimples were noted on the compressive side of the specimen, which was the last to fail. Figures C-12 through C-14 represent the three origins at 100 \times magnification, while Figures C-15 through C-17 show the origins at higher magnification (200 \times). Figure C-18 represents the morphology noted within the center of the specimen (mixed mode; ductile and transgranular) as illustrated in Figure C-10, while Figure C-19 represents the morphology of near the compressive side of the specimen. Figure C-20 is a high-magnification scanning electron micrograph representing the ductile region (final fast fracture) on the fracture surface.

Figure C-10. Schematic illustrating a mapping of the fractographic features of the surface shown in Figure C-9. Boxes represent location of figures.

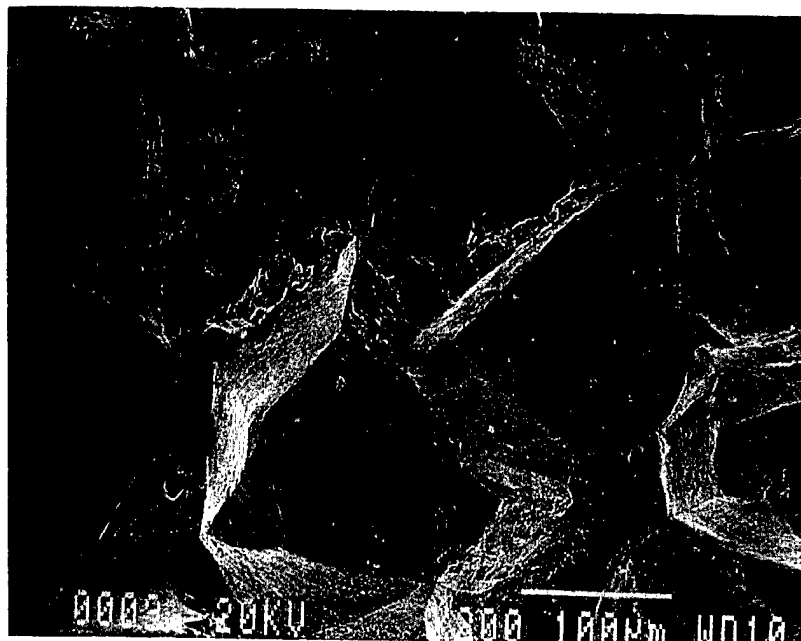
Figure D-2. Grains from the intergranular fracture surface of the failed strut mount (mag. 200 \times).

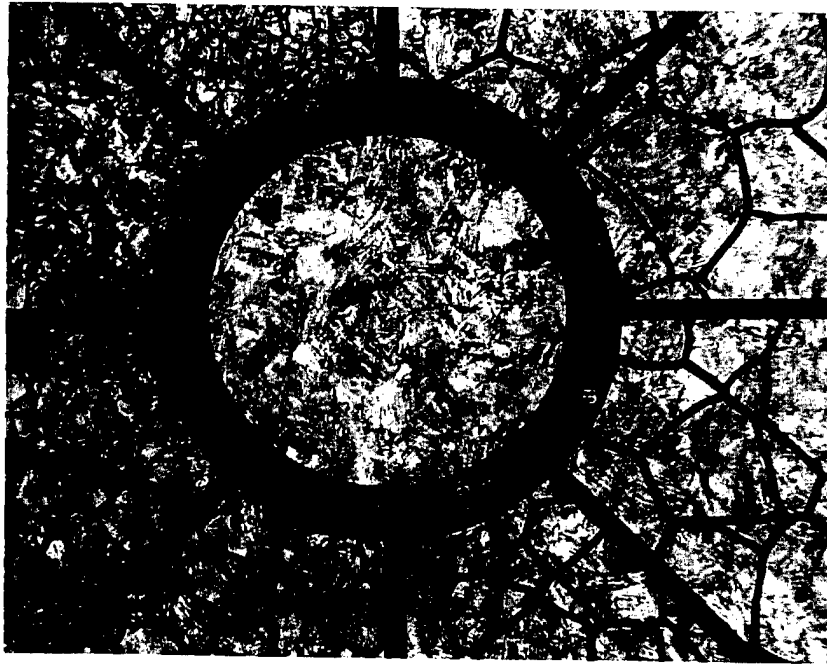
Figure D-5. Grain size of the Ft. Lewis specimen with reticle overlay.
Compare to Figure D-1 (mag. 100 \times).
